U.S. Department
of Transportation
**Federal Highway
Administration**

Guardrail Testing Program

Final Report

Publication No. FHWA-RD/FLP-90-087
May 1990

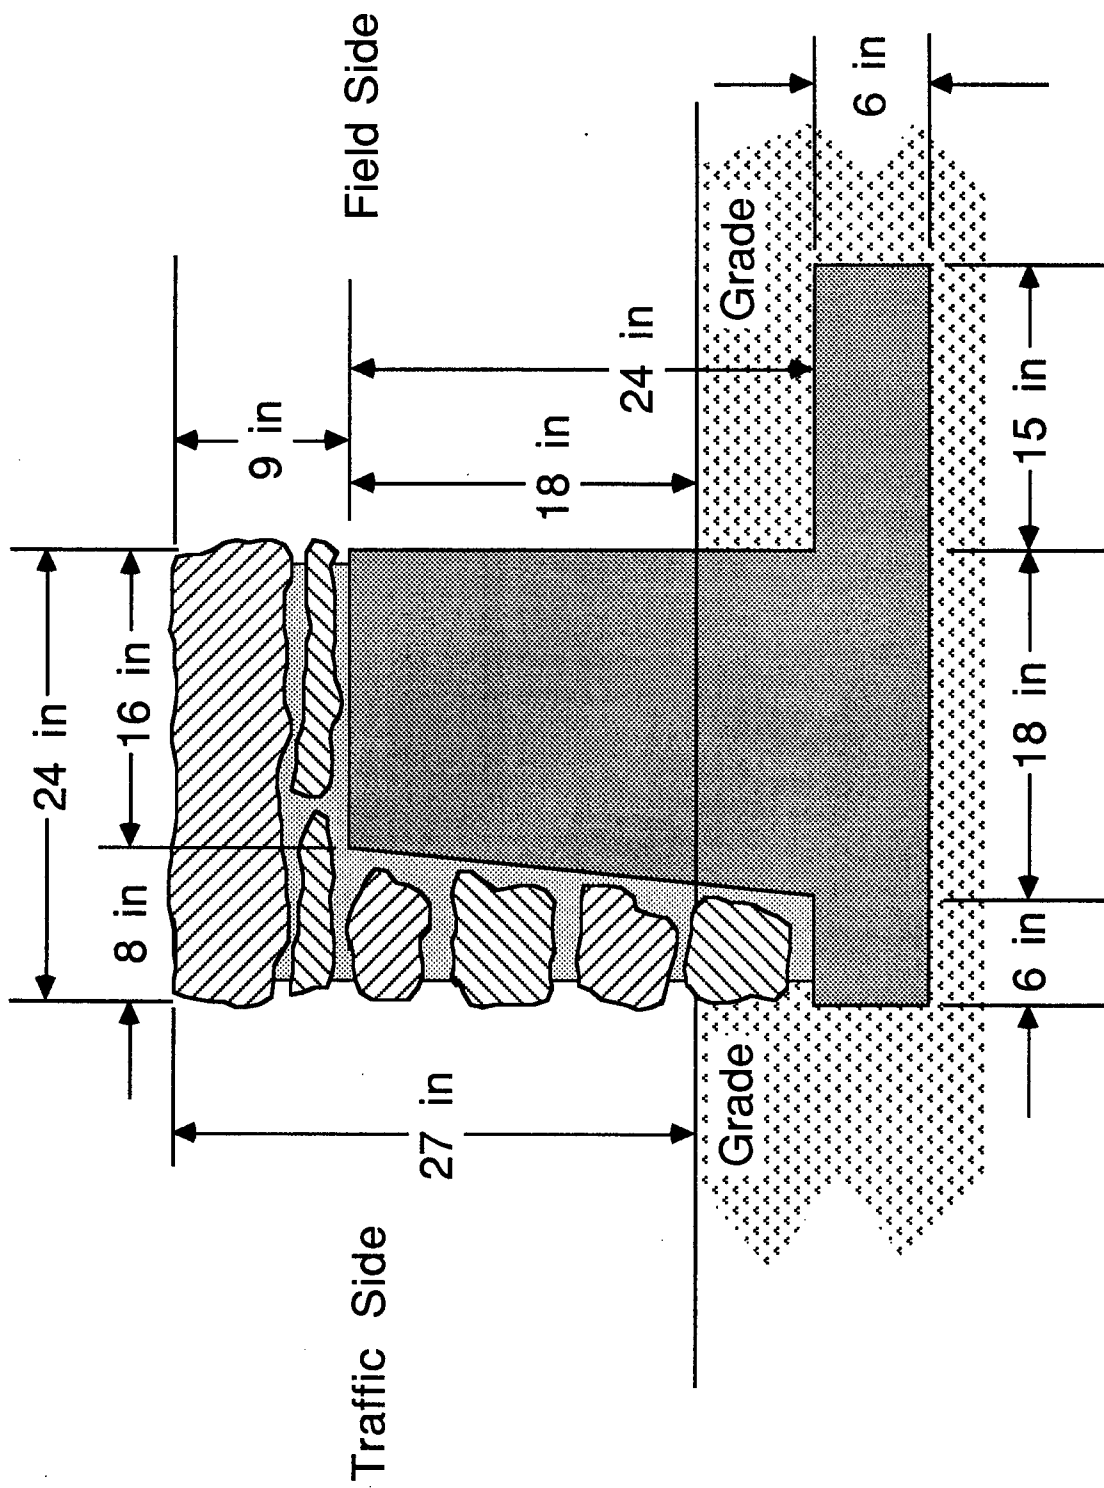
Figure 6. Stone masonry guardwall system.

As summarized in the full-scale test section, task E, the stone masonry guardwall was structurally inadequate under NCHRP 230 test 10 conditions. 15 ft (4.6 m) of coping stone was knocked 5 ft (1.53 m) behind the wall, 4 ft (1.22 m) of coping stone was angled back, and a one-piece coping stone was dislodged. Given that standard bumper heights for large sedans are 18 in (0.46 m) at the bumper center and the core height is 18 in (0.46 m) above ground level, the weakest point of the system is at the vertical impact point. The following recommendations are made to improve this design:

- Raise the core embedment depth 3 in (0.08 m) and reduce the coping thickness 3 in (0.08 m). Thus, the guardwall height remains at 27 in (0.69 m), however, the precast concrete core is contributing to the strength of the system.
- Use type S mortar instead of the present type N mortar. This will increase the mortar compressive strength from 750 lb/in² (5168 kPa) to 1200 lb/in² (8268 kPa), a 60 percent increase. The increase in cost is minimal.
- Improve the masonry to core top shear resistance by providing a 4-in wide by 4-in (0.10-m by 0.10-m) deep keyway in the center of the top of the precast core. Vertical dowels can also be used to strengthen the system, however these are not felt to be necessary.

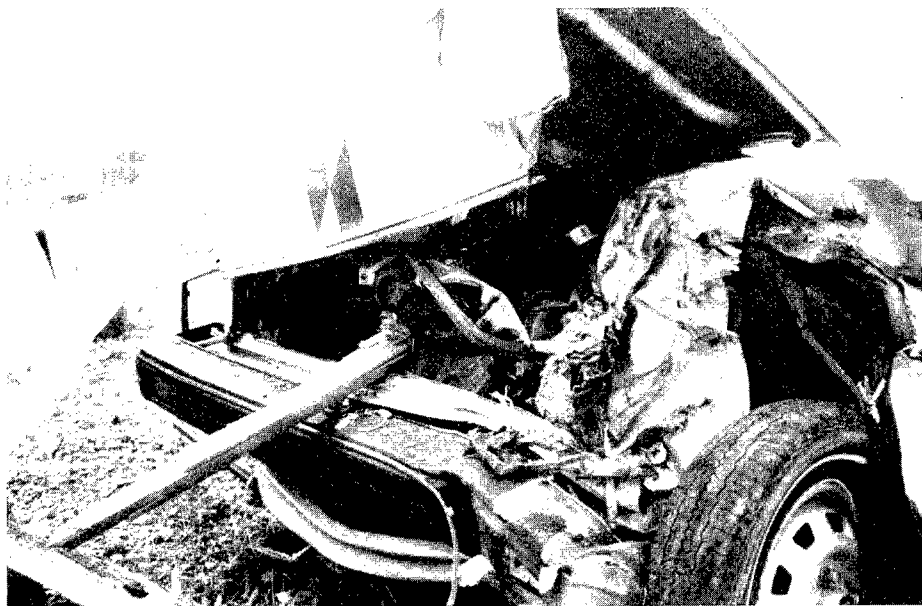
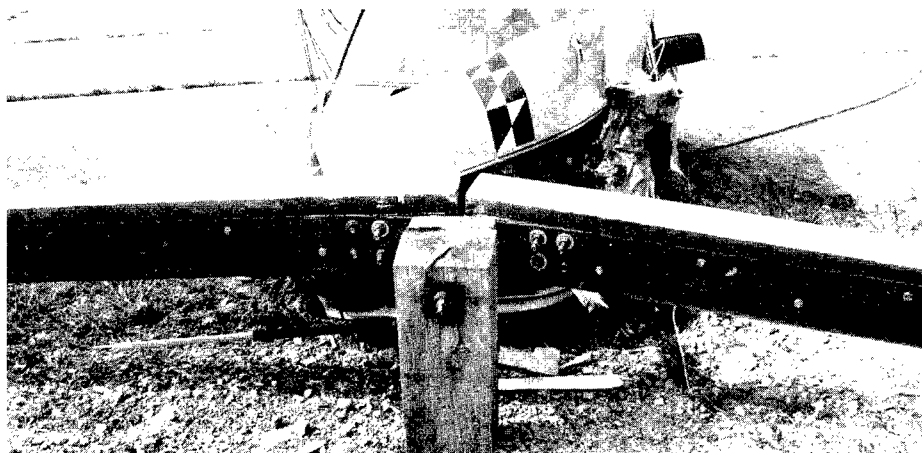
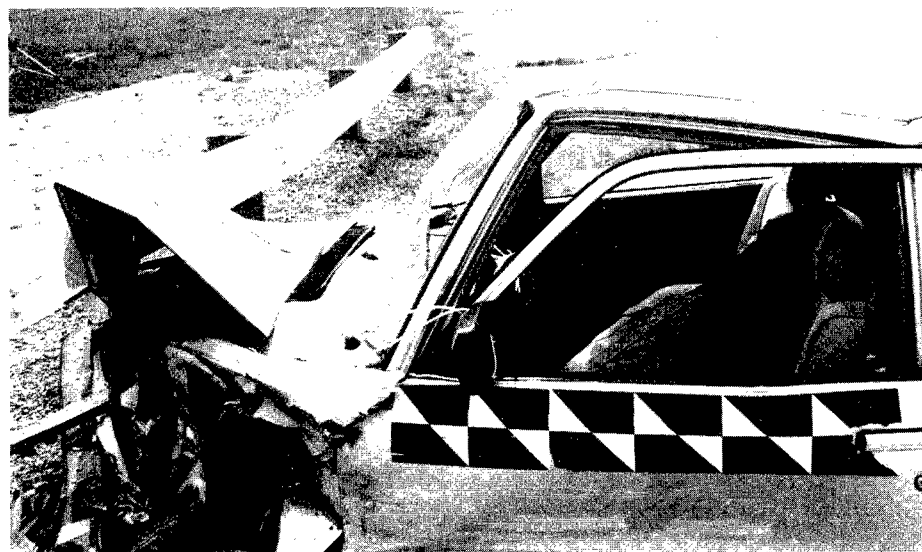
Figure 17. Posttest photographs of test vehicle,
test 1818-5-1-87.

Damage occurred mainly to the left front fender, grill and bumper. The driver side door was wedged outward and the windshield and driver side window glass were shattered. Posttest photographs of the vehicle are shown in figure 17.

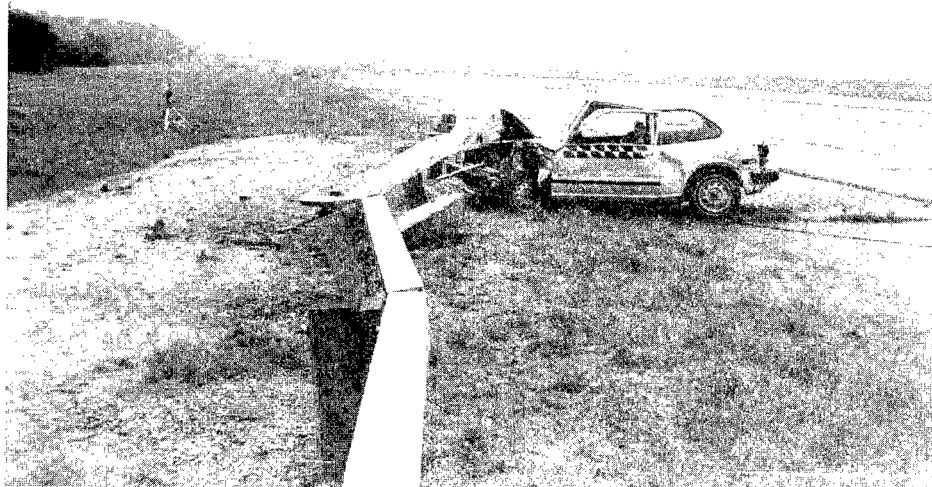
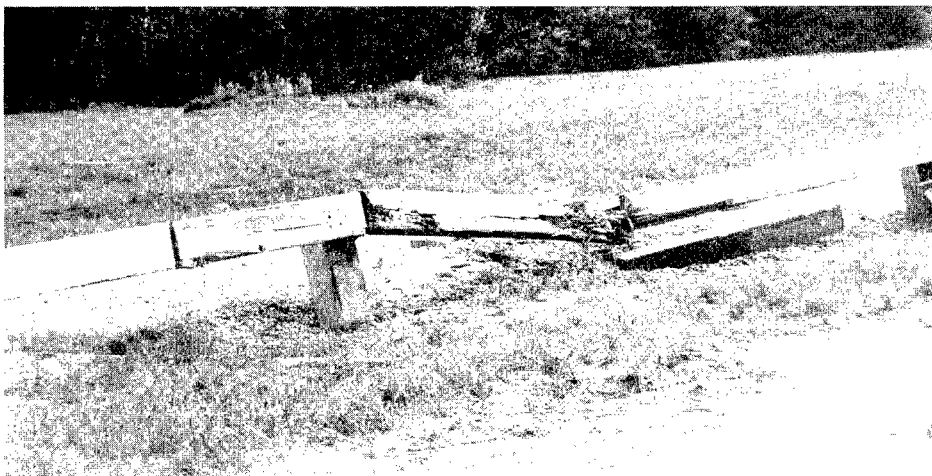
Figure 18. Posttest photographs of guardrail system,
test 1818-5-1-87.

Due to the severe impact that occurred at post 6, the splice plate and all connection hardware were bent or sheared. The fifth rail and the sixth post and blockout were severely damaged. Posttest photographs of the guardrail are shown in figure 18.

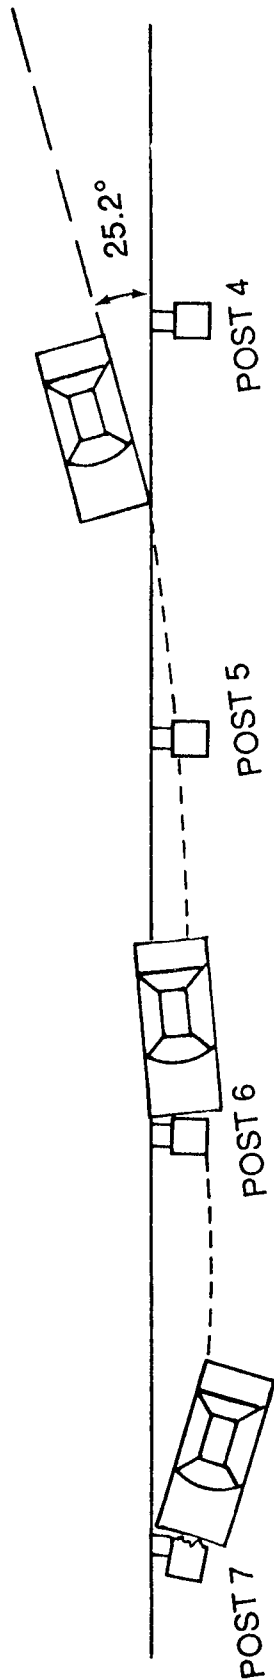
Figure 23. Test summary, test 1818-5-2-87.

Ridgedown Acceleration:		20/30 ft/s 15/20 g's	
		TRC 191:			
		Peak 50 ms acceleration:		-9.2 g's -14.7 g's	
		Longitudinal:			
		Lateral:			
		14. Test Results Conclusion:		Vehicle was not smoothly redirected by the rail. The vehicle underrode the guardrail. The guardrail failed at post 6. Vehicle squarely impacted post 7. Test was not successful.

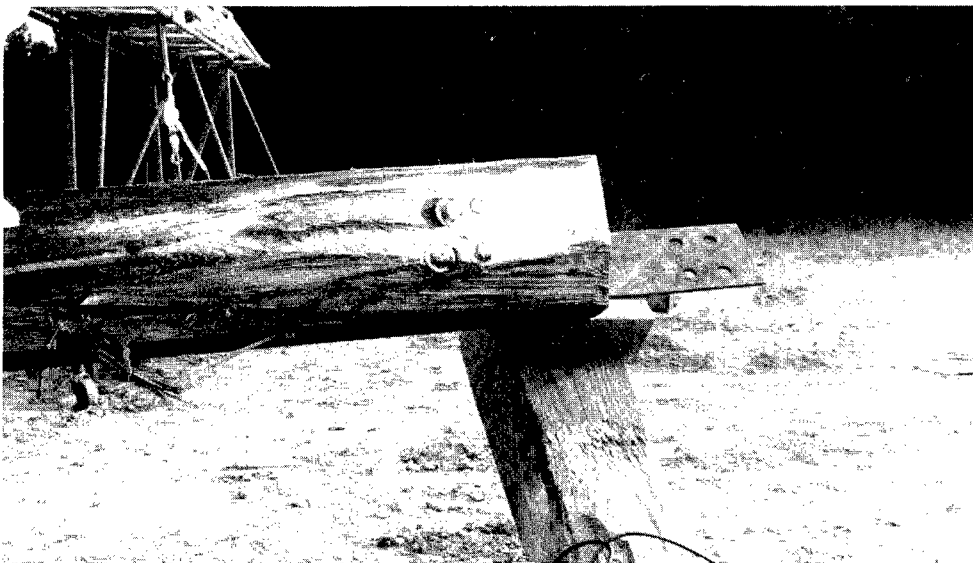
Figure 26. Posttest photographs of guardrail system, test 1818-5-2-87.

Due to the failure of the posts and the connection hardware at post 5, a significant amount of damage occurred. Posts 5, 6 and

7 were broken at or below ground level. Post 6 was cracked open at the top where the rail attachment bolt pulled out. The four 8.5-in (0.22-m) long carriage bolts were sheared off at the upstream end of rail 4. Three splice plates were bent significantly. Posttest photographs of the guardrail are shown in figure 26.

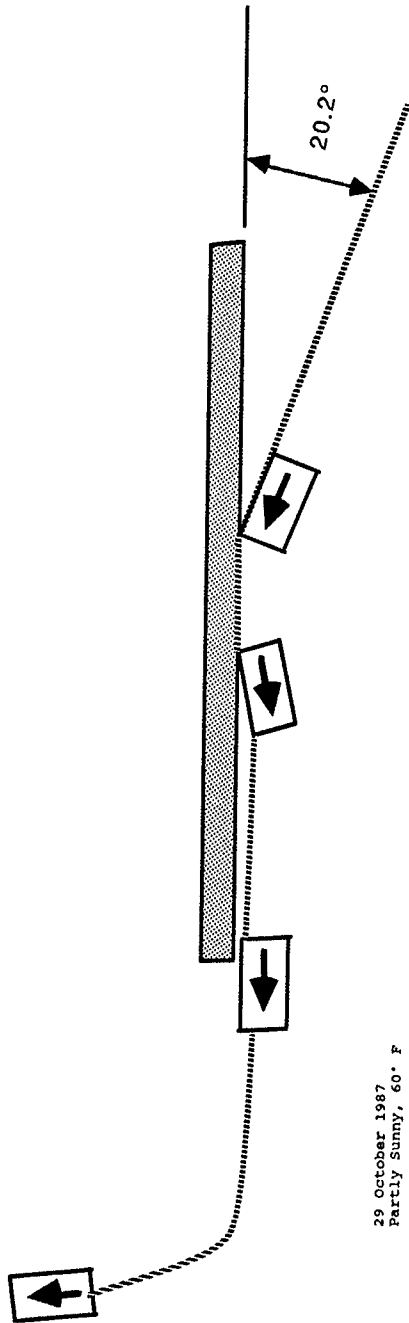
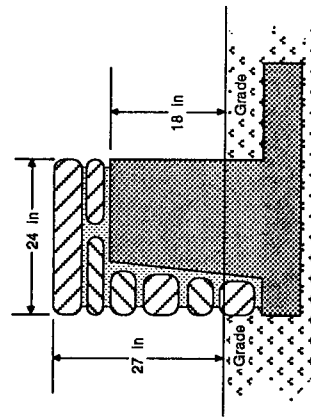
Figure 31. Test summary, test 1818-5-3-87.

Vehicle was redirected by the guardwall at 44.0 mi/h and 4.5 degrees. Because the vehicle did not intrude or come to rest in the adjacent traffic lanes, the vehicle slowdown criteria does not apply. Negligible damage was done to the guardwall.

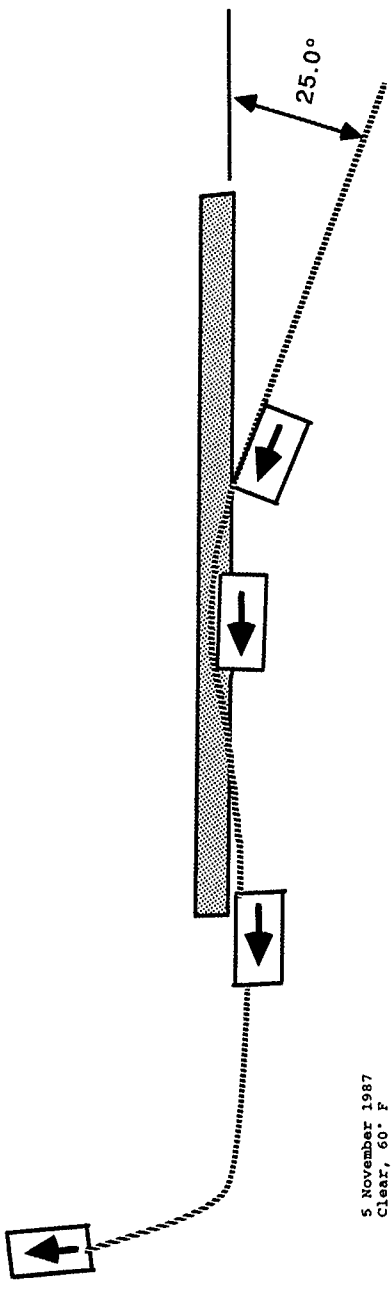
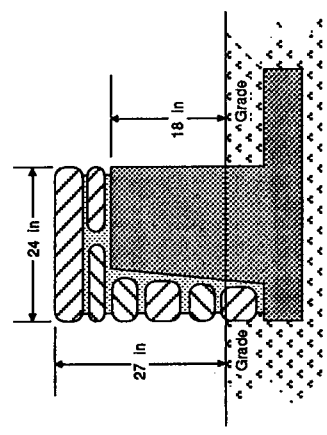
Figure 39. Test summary, test 1818-5-4-87.

Vehicle rode up on guardwall and was redirected. Significant damage occurred to guardwall - 20 ft of coping stone knocked off top of wall. Vehicle was redirected by the guardwall at 36.4 mi/h and 4 degrees. Because the vehicle did not intrude or come to rest in the adjacent traffic lanes, the vehicle slowdown criteria does not apply.

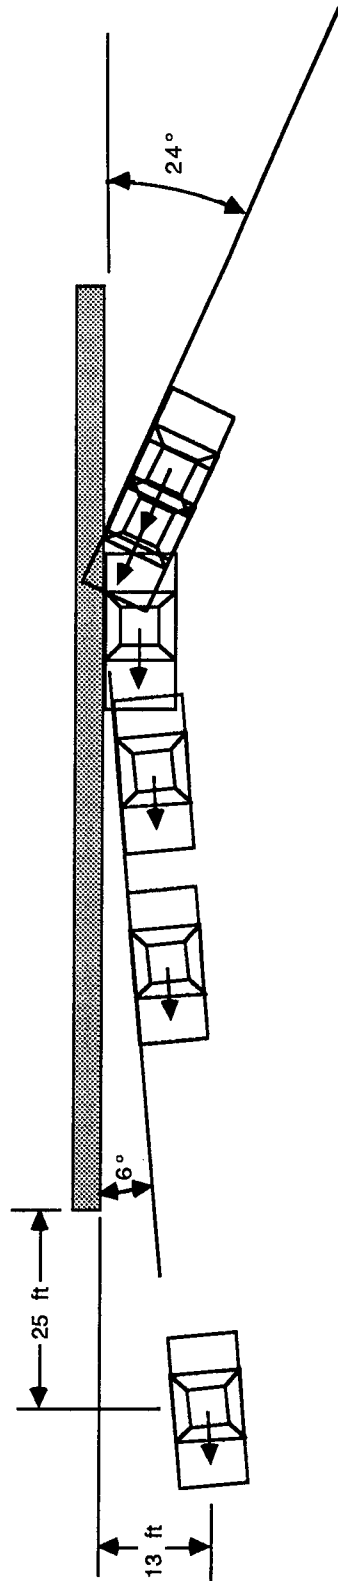
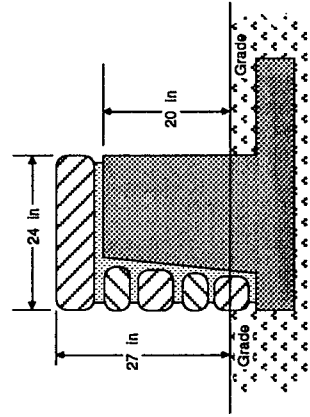
Figure 47. Test summary, test 1818-5-88.

7. Redirection Speed:	37.9 mi/h (55.6 ft/s)
8. Total Speed Change:	23.1 mi/h (33.9 ft/s)
9. Total Momentum Change:	4895 lb-s
10. Vehicle Damage Index: (SAE J224a)	01RFEW3
11. NCHRP 230 Test Number:	10
12. Impact Severity:	$\frac{m(V \sin \alpha)^2}{2}$
13. Test Results Conclusion:	Vehicle was smoothly redirected by the guardwall at 37.9 mi/h and 6 degrees. Because the vehicle did not intrude or come to rest in the adjacent traffic lanes, the vehicle slowdown criteria does not apply.

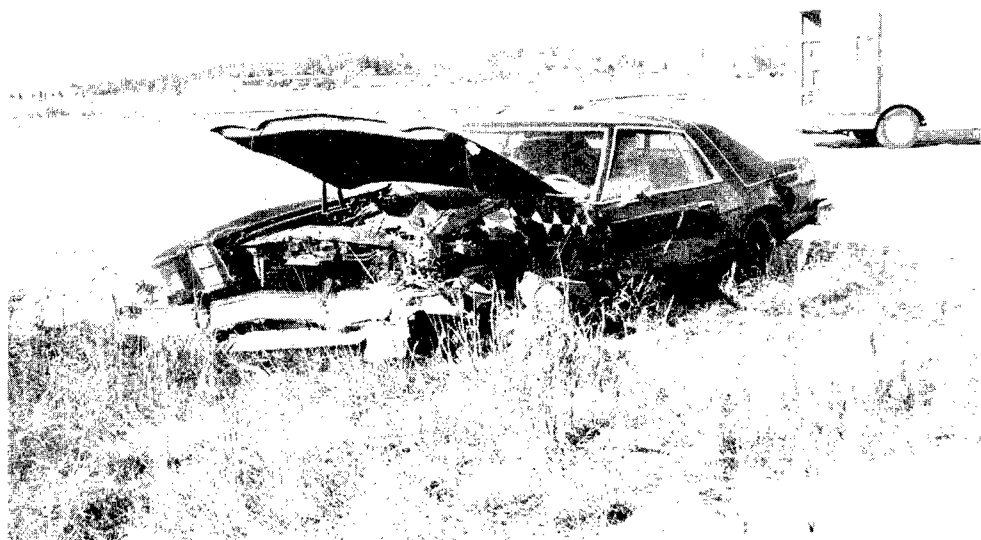
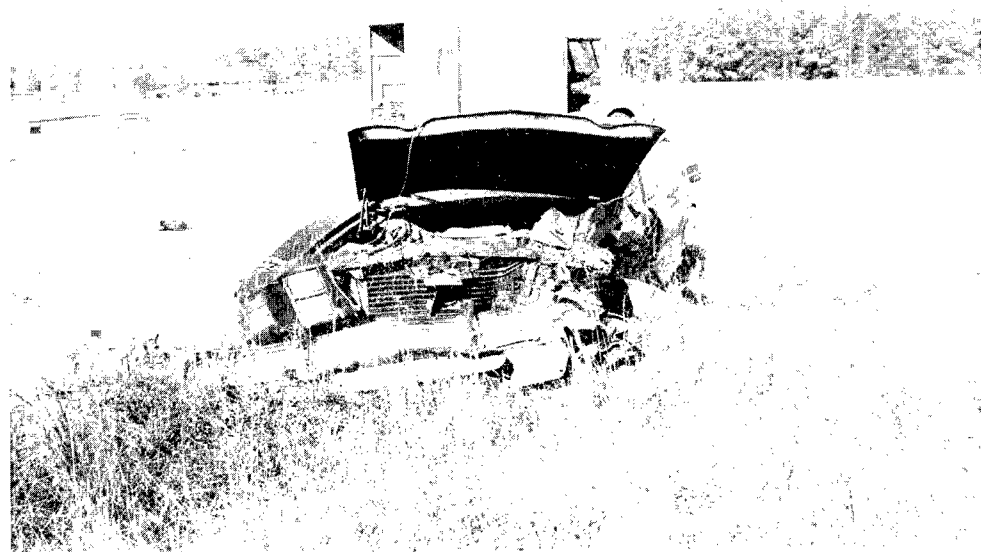
Figure 56. Posttest photographs of test vehicle,
test 1818-5-6-87.

Vehicle damage occurred mainly to the left front fender, grill bumper, and suspension/steering. The front left wheel was damaged from post snagging causing the tire to deflate. The driver side door was wedged outward. The windshield and the drivers side window glass were shattered. Posttest photographs of the vehicle are shown in figure 56.

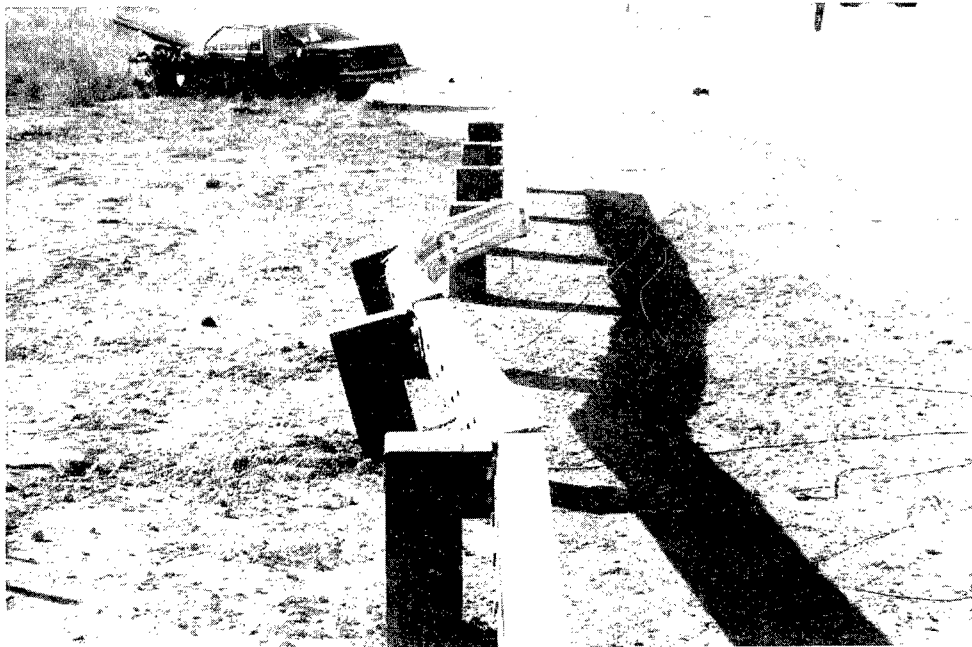
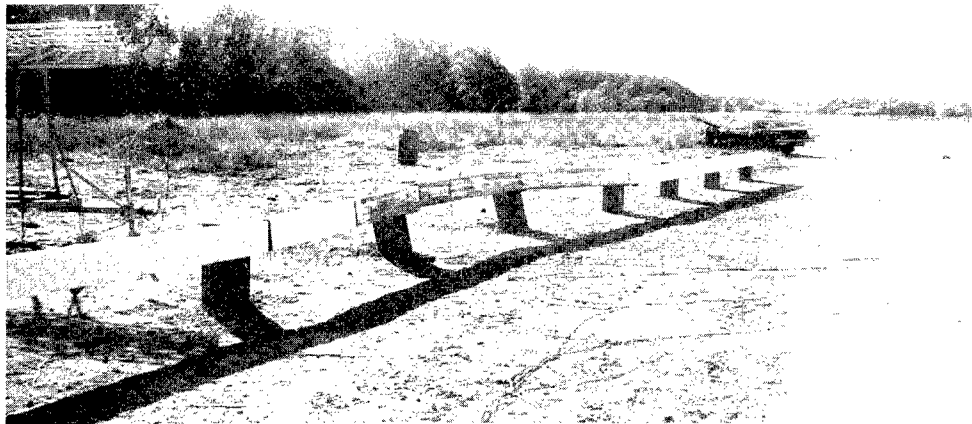
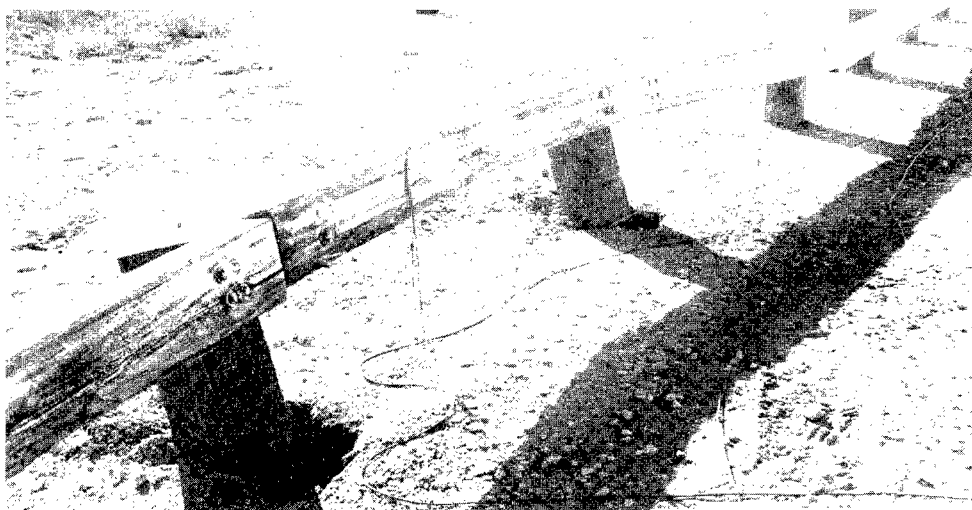
Figure 57. Posttest photographs of guardrail system,
test 1818-5-6-87.

Damage to the guardrail system was minimal. The 6 in by 10 in (0.15 m by 0.25 m) timber part of the fifth rail snapped due to pocketing of the vehicle. There was a 16 in (0.41 m) long crack at the trailing end of rail 4. This crack was mostly cosmetic. A 0.5-in (0.013-m) strip of wood was torn off the front corner of post 6. The blockout of post 6 was cracked throughout its entire length. Posttest photographs of the guardrail are shown in figure 57.

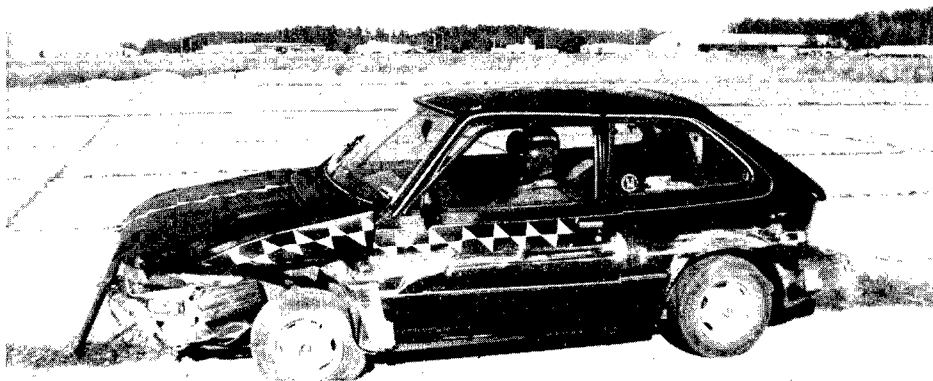
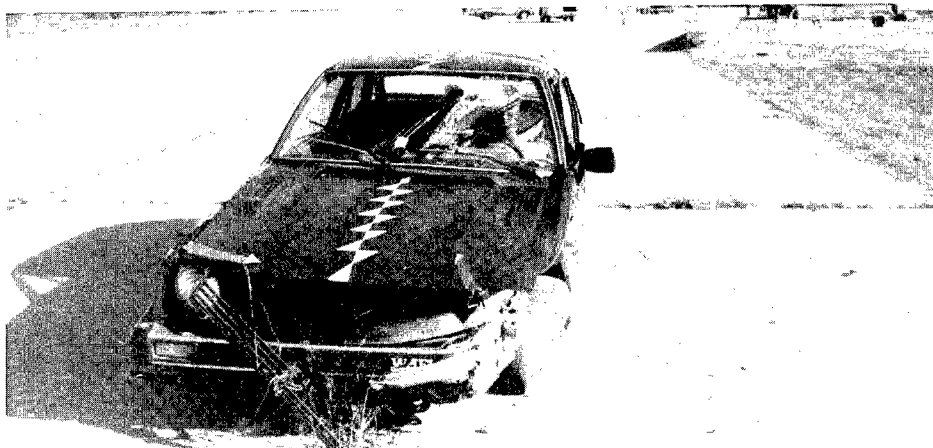
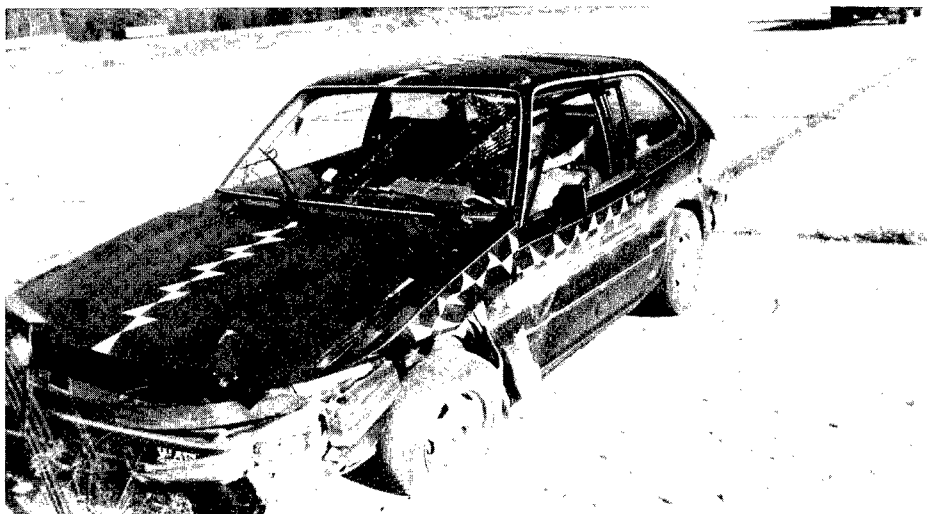
Figure 64. Posttest photographs of test vehicle,
test 1818-7-88.

Vehicle damage occurred mainly to the left side and front of the car. The left front fender, grill, bumper, drivers door, vehicle steering suspension were damaged significantly. Posttest photographs of the vehicle are shown in figure 64.

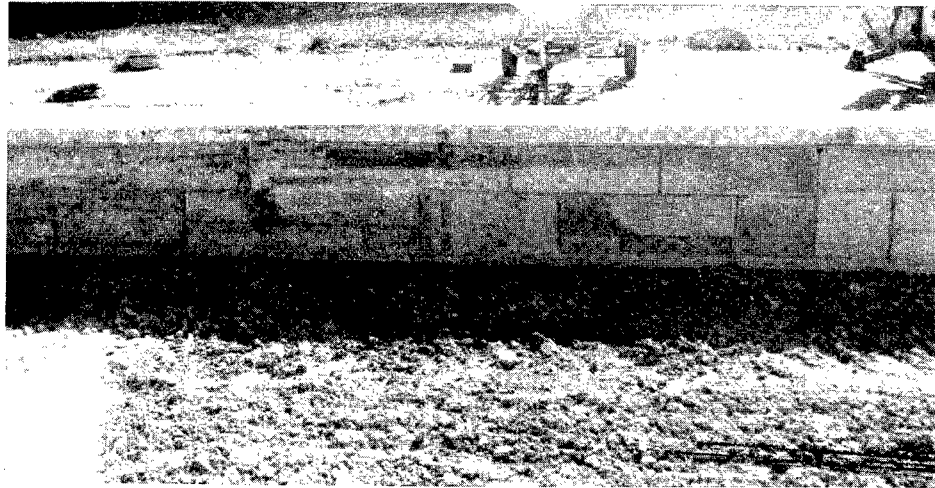
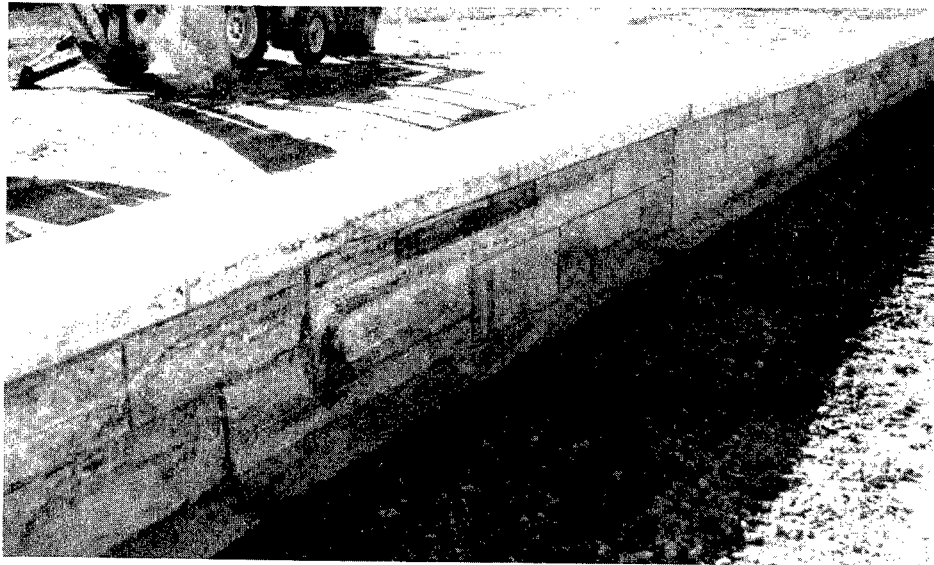
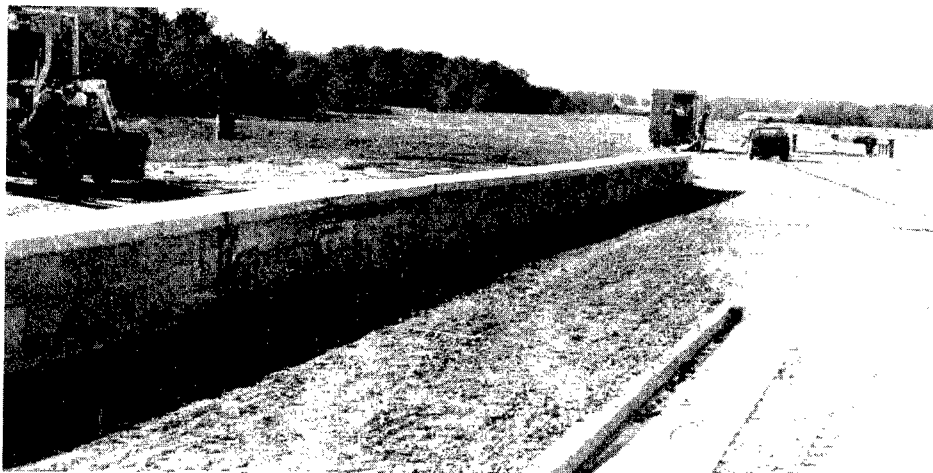
Figure 65. Posttest photographs of median barrier system, test 1818-7-88.

This barrier performed well. The vehicle was redirected. Some light marring of the concrete occurred at the impact point. The barrier showed no permanent deformation. Posttest photographs of the median barrier are shown in figure 65.

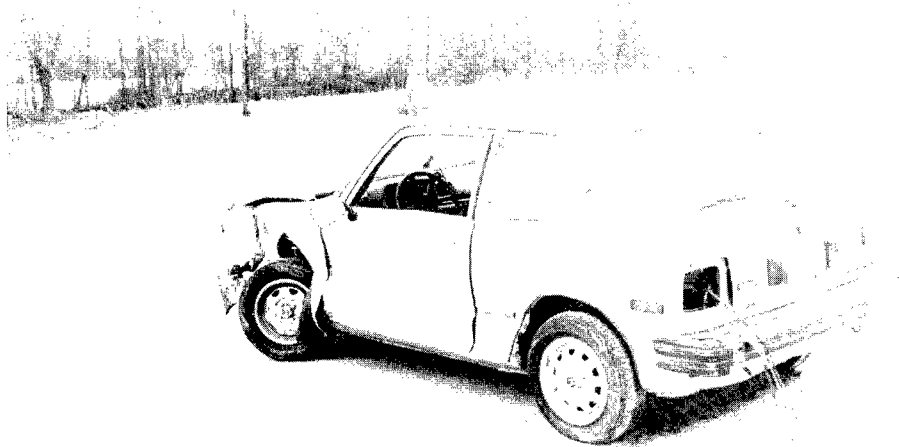
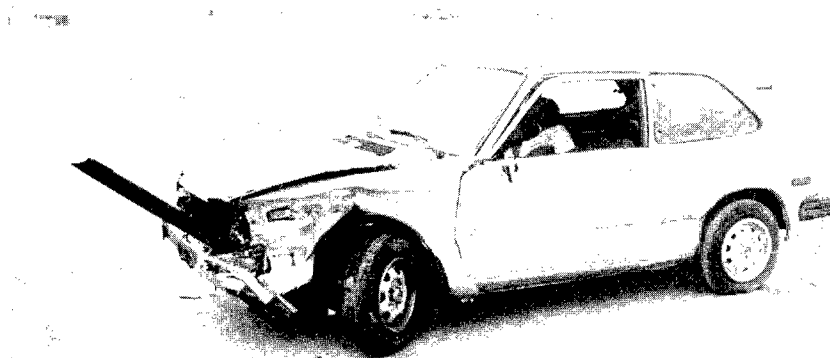
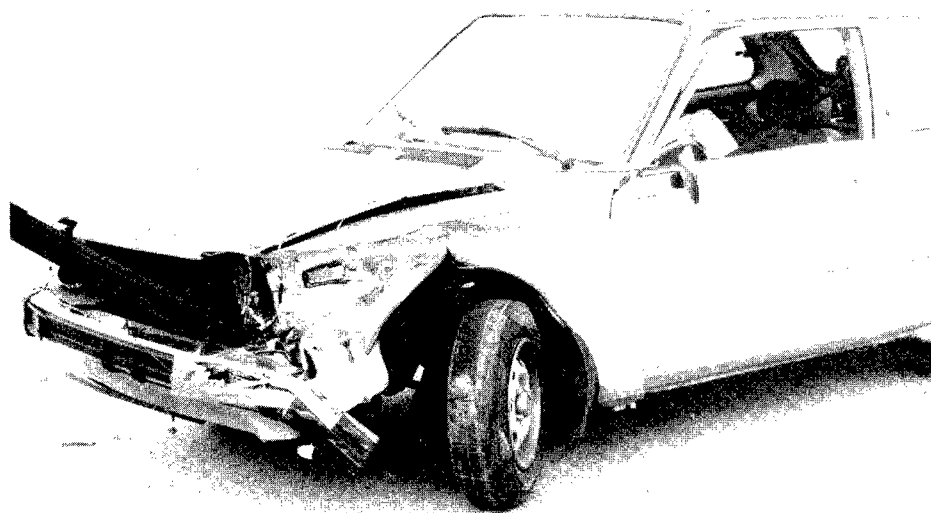
Figure 72. Posttest photographs of test vehicle,
test 1818-8-88.

Vehicle damage occurred mainly to the left side of the car. The left front fender, grill, bumper, and drivers door were damaged significantly. Posttest photographs of the vehicle are shown in figure 72.

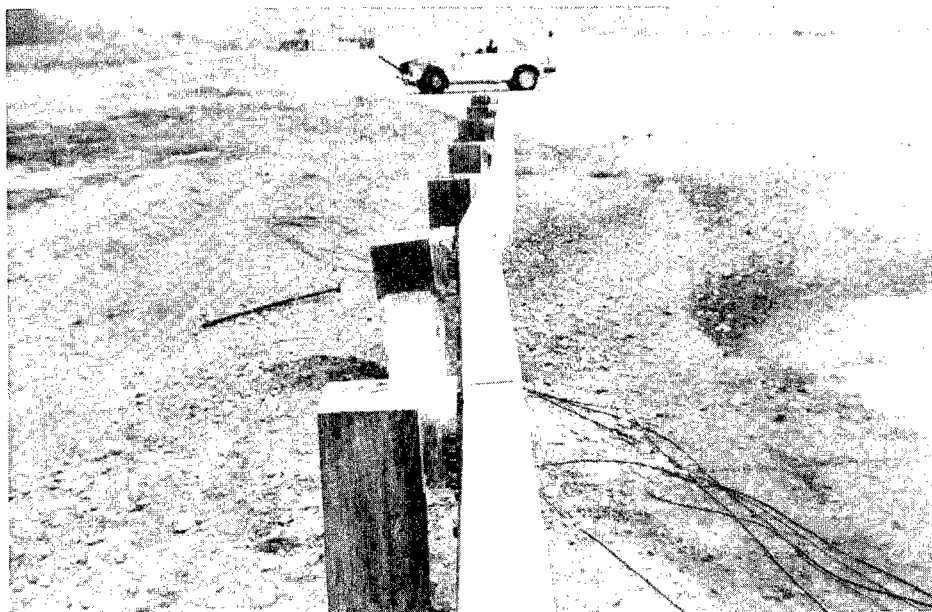
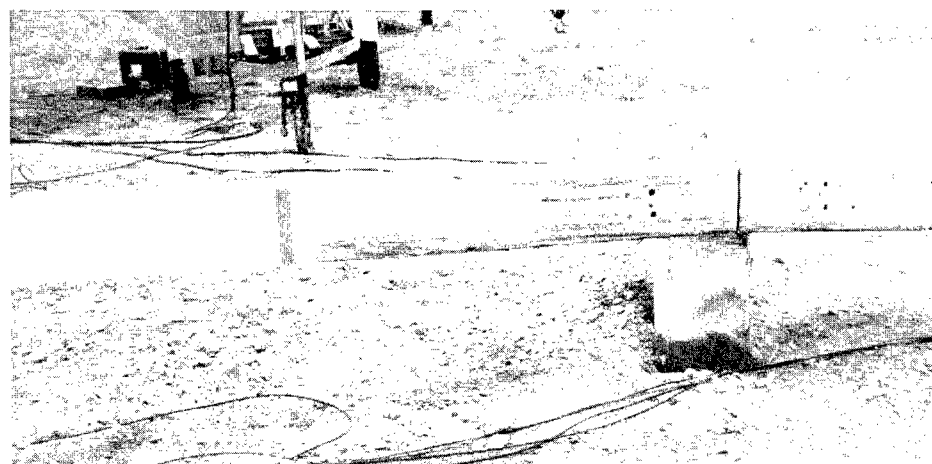
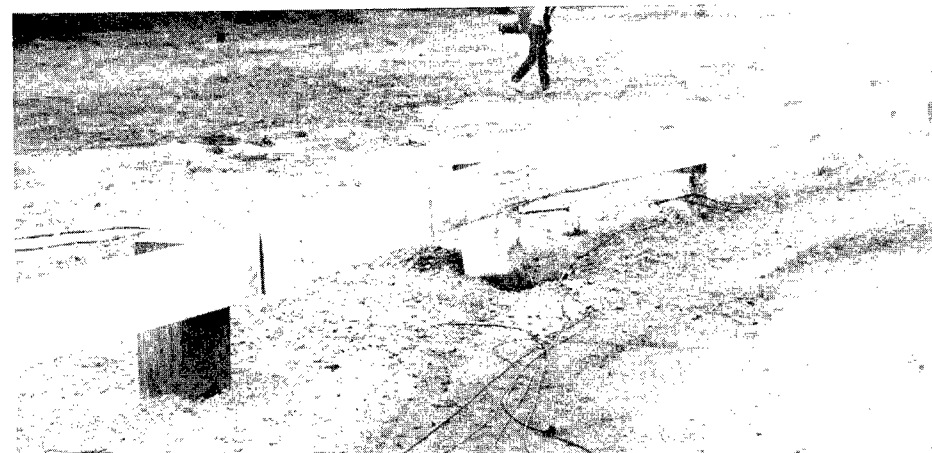
Figure 73. Posttest photographs of guardrail system, test 1818-8-88.

This guardrail performed well. The vehicle was redirected. There was tire scrub on the front of post 5 and the front and side of post 6. Post 6 was impacted by the vehicle front wheel. The bottom of the rail showed tire scrub for 18 ft (5.5 m) (from 2 ft (0.61 m) past impact to midspan of rail 6). The rail at post 5 was pushed back approximately 8 in (0.20 m) dynamically and 5 in (0.13 m) statically and was pushed up approximately 5 in (0.13 m) dynamically and 2.5 in (0.06 m) statically. A portion of the push back and lift were actually rail and splice twist. Posttest photographs of the guardrail are shown in figure 73.

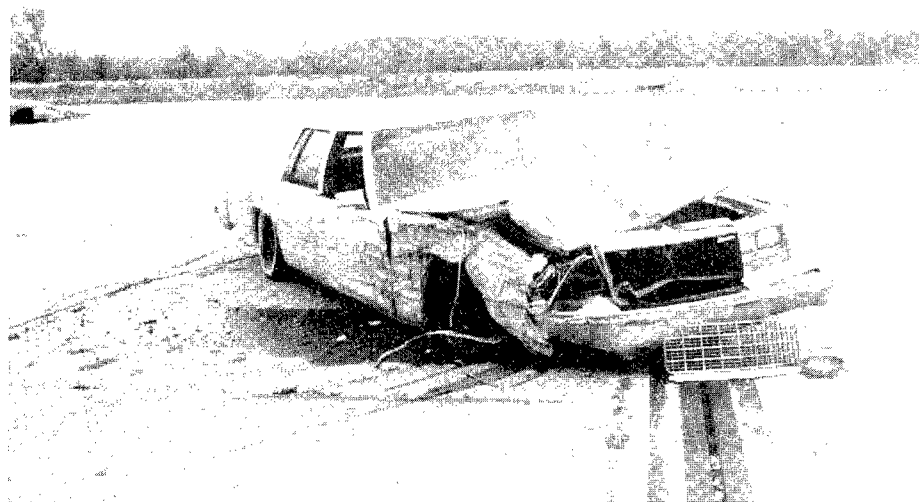
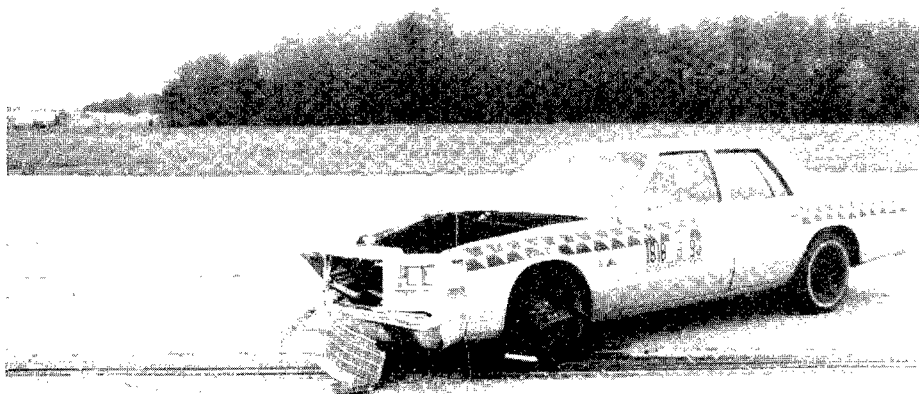
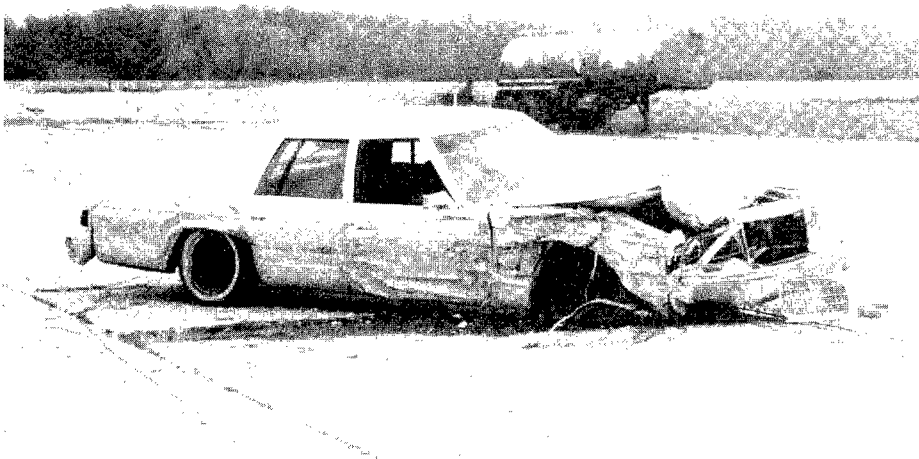
Figure 80. Posttest photographs of test vehicle,
test 1818-9-90.

Damage occurred to the grill, front bumper, hood and entire right side of the vehicle. The passenger side door was pushed out due to the impact of the passenger dummy. Posttest photographs of the vehicle are shown in figure 80.

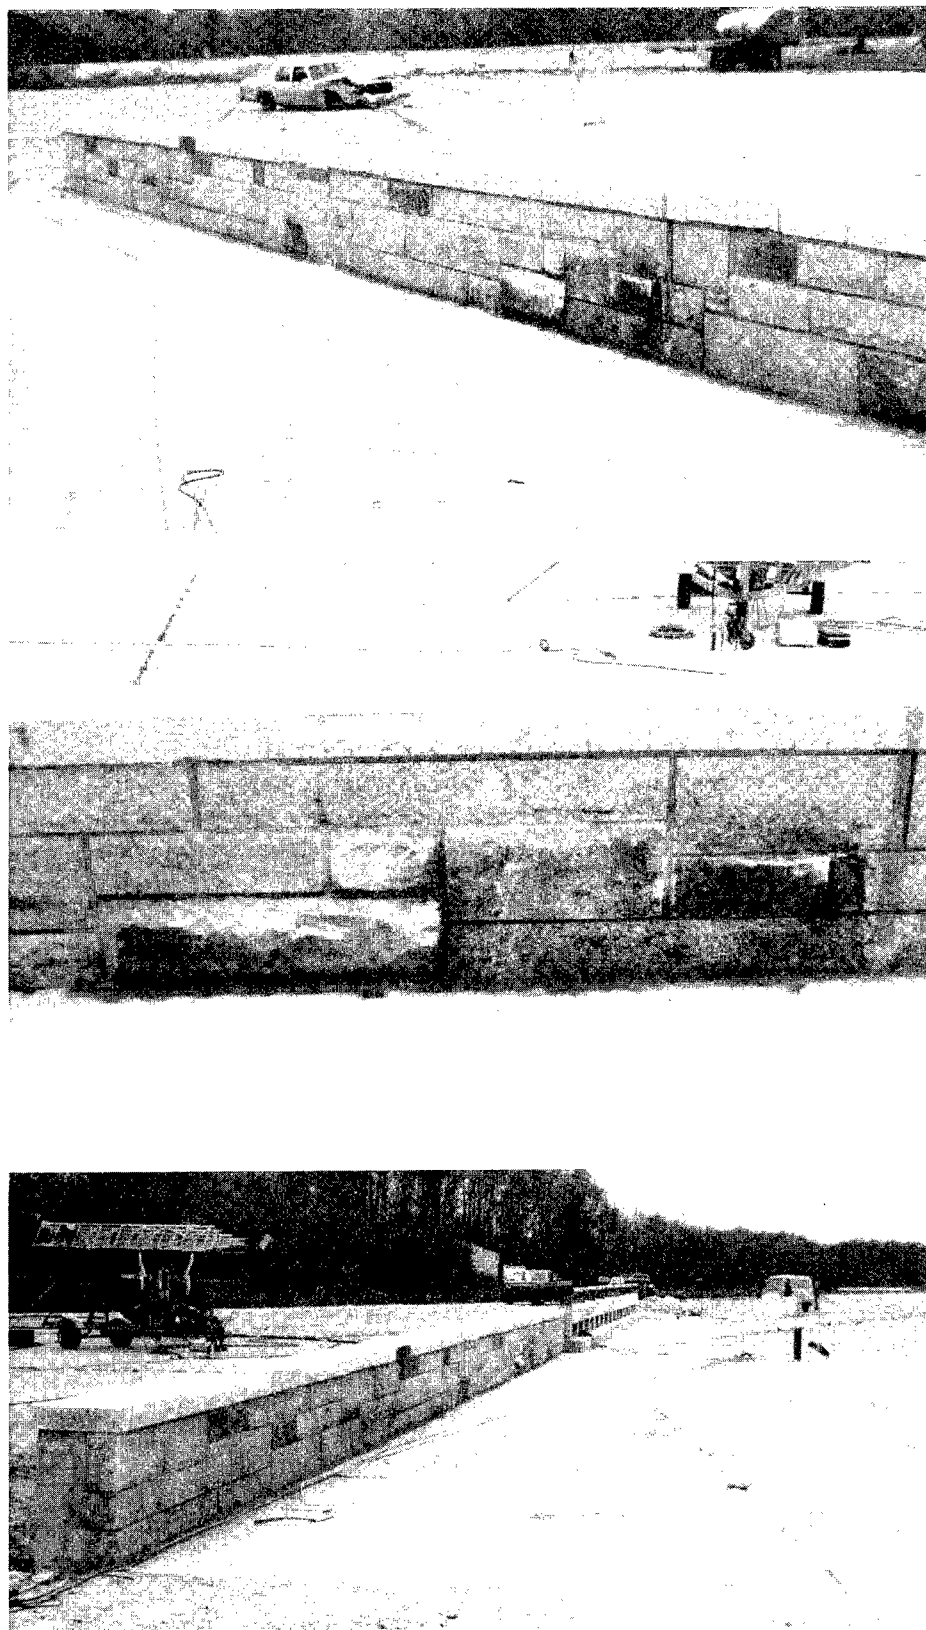
Figure 81. Posttest photographs of bridge rail system,
test 1818-9-90.

The bridge rail showed only minor scuffing for the 15 ft (4.6 m) that the vehicle was in contact. Other than this scuffing, there was no damage to the bridge rail. Posttest photographs of the bridge rail are shown in figure 81.

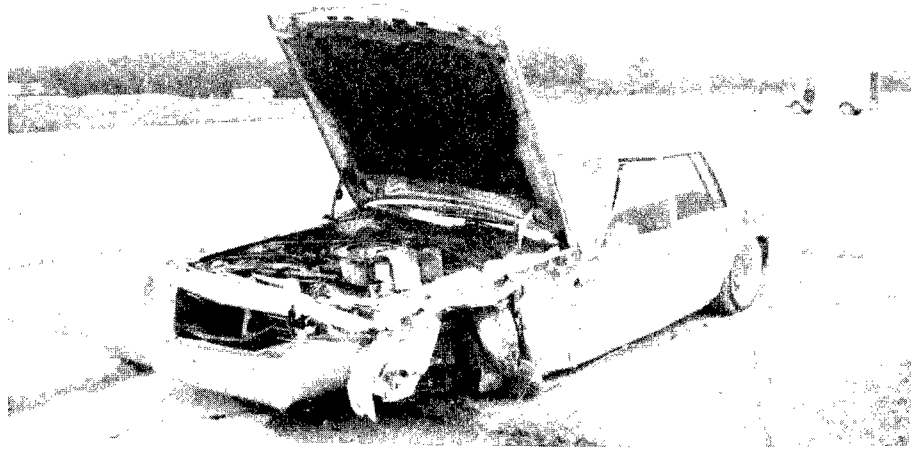
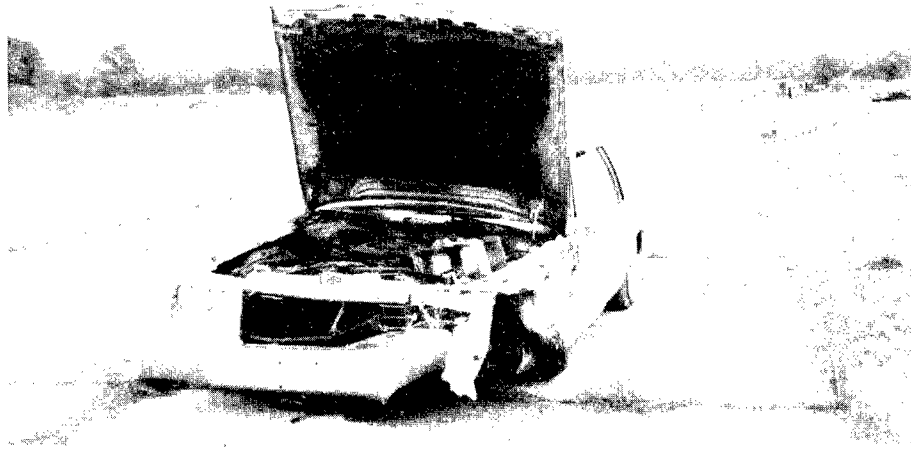
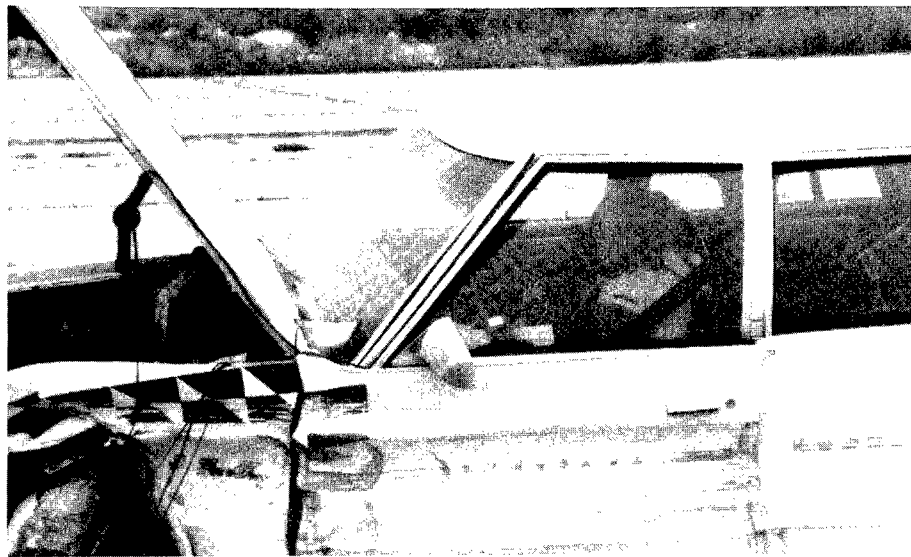
Figure 88. Posttest photographs of test vehicle,
test 1818-12-88.

Vehicle damage occurred mainly to the left side and front of the car. The left front fender, grill, bumper, drivers door, vehicle steering suspension were damaged significantly. Posttest photographs of the vehicle are shown in figure 88.

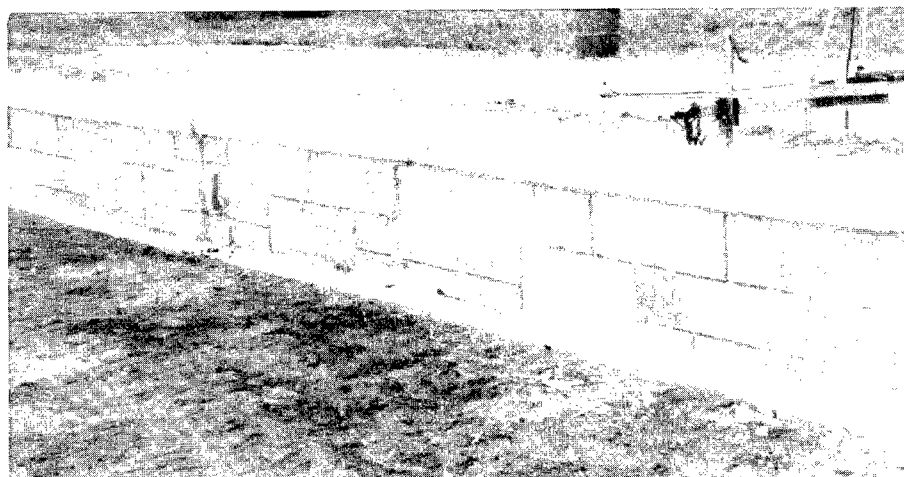
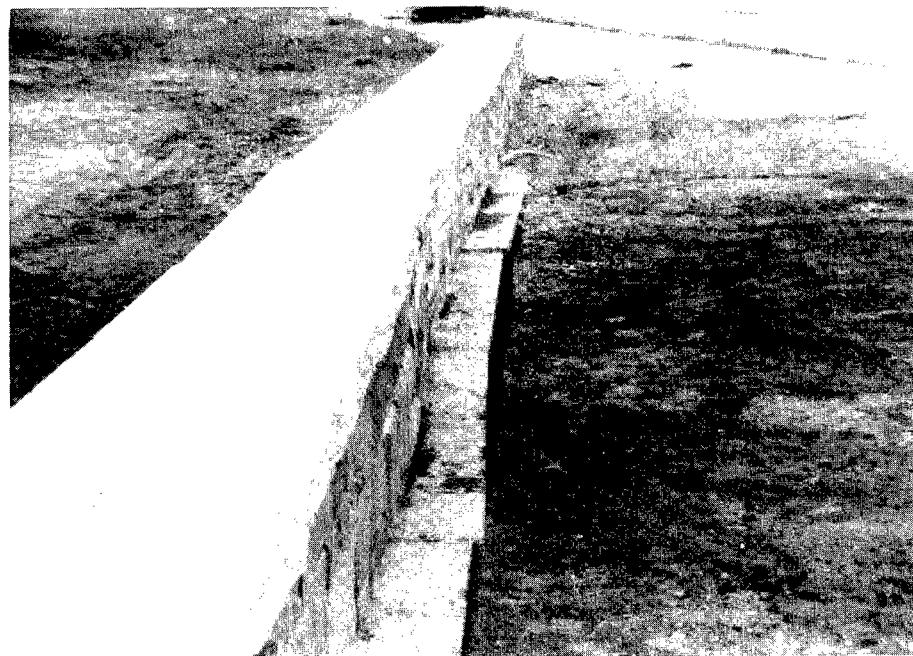
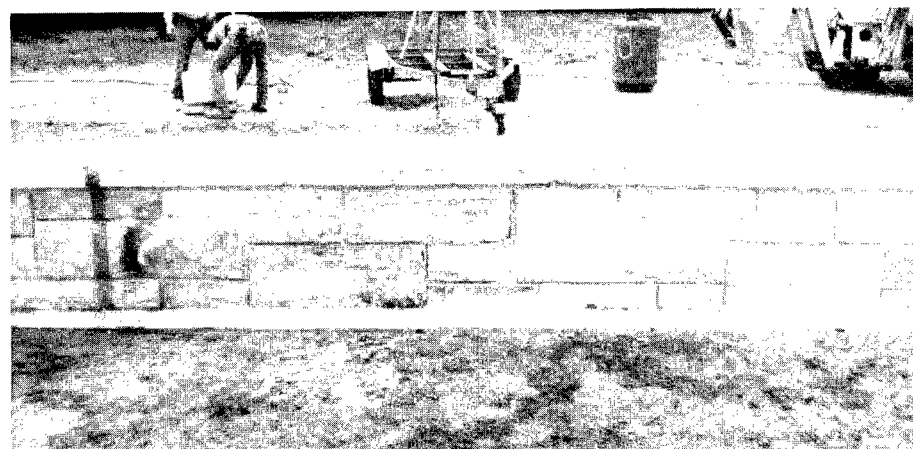
Figure 89. Posttest photographs of median barrier system, test 1818-12-88.

This barrier performed well. The vehicle was redirected. During the impact, the impact section and the next section downstream

rotated back out of the line of the barrier approximately 3 in (0.08 m). Statically, the sections were also pushed back slightly. The maximum push back occurred at the section joint downstream of impact and was measured to be 3 in (0.08 m). Posttest photographs of the median barrier are shown in figure 89.
